CENTRAL INTELLIGENCE AGENCY
INFORMATION REPORT

COUNTRY Poland
SUBJECT Port Information: Gdansk

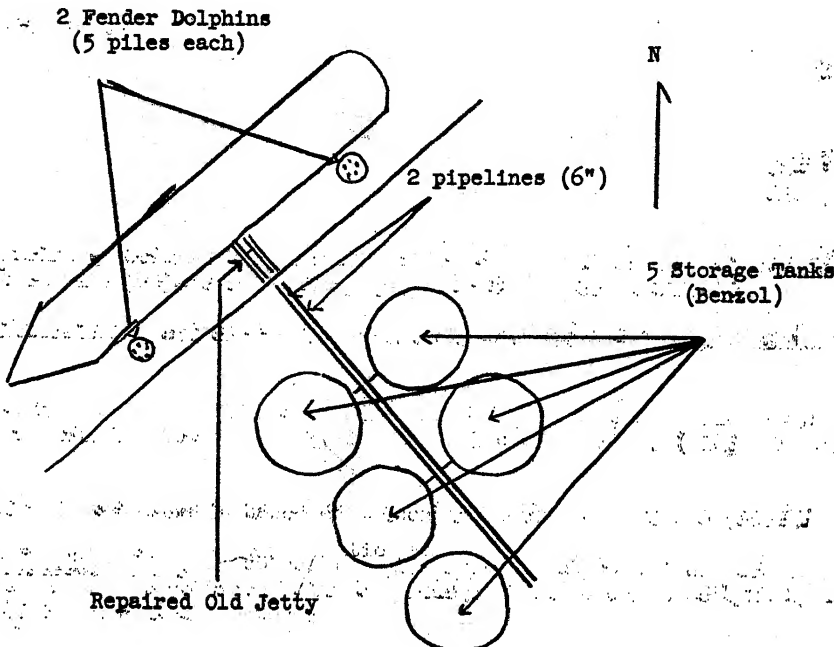
8. Berth Vessel berthed at benzol loading wharf at designator B. Wharf was an old Jetty that has been recently repaired, and two new fender dolphins of five piles each have been sunk into the channel to facilitate berthing. Wharf arrangement and tank storage area layout is drawn below:

10. Cargo Operations Vessel pumped ballast before boarding inspection, cleaned tanks after inspection was completed, received clearance to load at 082000A [] [] and commenced loading cargo immediately from two 6" pipelines leading from five benzol storage tanks. Vessel loaded 2557 metric tons benzol at a rate of approximately 200 tons per hour, and completed operation at 091100A [] []. Four or five line operators were on duty on the wharf and aboard ship during the loading operation.
